PAINT INDUCED ELEVATION OF OIL POWER FACTOR IN ELECTRICAL EQUIPMENT

By: E. R. Crutcher*, Phil Hopkinson#, Ray Rettew#, Steve Smith%, Ken Warner*, and Jaime LaFave®
* Microlab Northwest, # HVolt Inc., % Kuhlman Electric Corporation, ® TJH2b Analytical Services Inc.

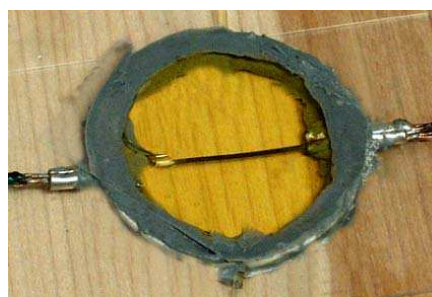
PHOTOGRAPH 1: MicroCell Used to Test Oils for Film-Forming Compounds

The cell is about an inch and a quarter in diameter and designed to fit on the stage of a microscope. The center bar is a copper plated heating element on which the film is deposited as the oil flows through the cell.

A new tool for investigating insulating oils had been developed by two of the authors (Crutcher and Warner) as part of an EPRI project along with TJH2b. This device is called a MicroCell and is basically a heated copper surface over which oil flows while being observed under a microscope². Photographs 1 and 2 show the MicroCell and how it is used. After observing the oil under carefully controlled conditions the copper heating element can be examined chemically using a Fourier Transform Infrared Spectrophotometer attached to a microscope (Photograph 3). The functional group signature of the film on the copper helps identify the compounds responsible for the behavior of the oil. In this case the behavior of the oil in the cell and its chemical signature were unique. The oil very rapidly reacted with the copper element at a temperature of 120° Celsius, releasing a gas and forming a film on the copper. The chemical signature of the film indicated a low aliphatic hydrocarbon peak (carbon-hydrogen bonding) with much more activity in the carbonyl region (carbon-oxygen bonding, see Figure 1). The films from older transformers with high power factors tend to show high hydrocarbon peaks (see Figure 2).

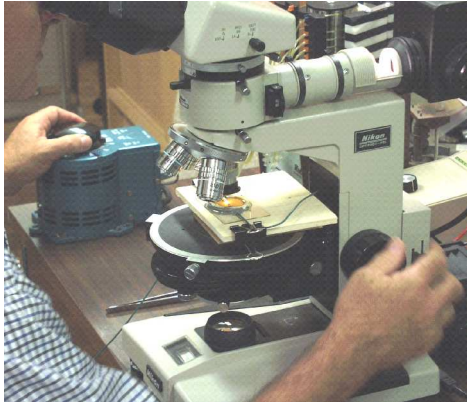
PHOTOGRAPH 2: MicroCell Mounted on the Microscope

The heated copper surface can be observed during the test to characterize the reactions occurring at any given time. Temperature and flow rate can also be changed while the system is being observed.

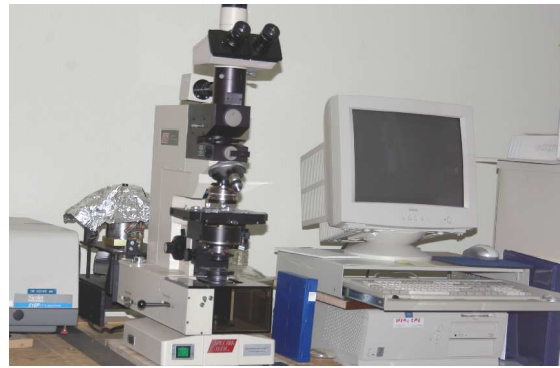
PHOTOGRAPH 3: Fourier Transform Infrared Microscope Spectrophotometer

With this instrument films a few tenths of a micrometer thick with diameters of about ten micrometers can be analyze. The system is used in the reflection mode with a polished copper of stainless steel substrate resulting in a dual-pass transmission spectrum.

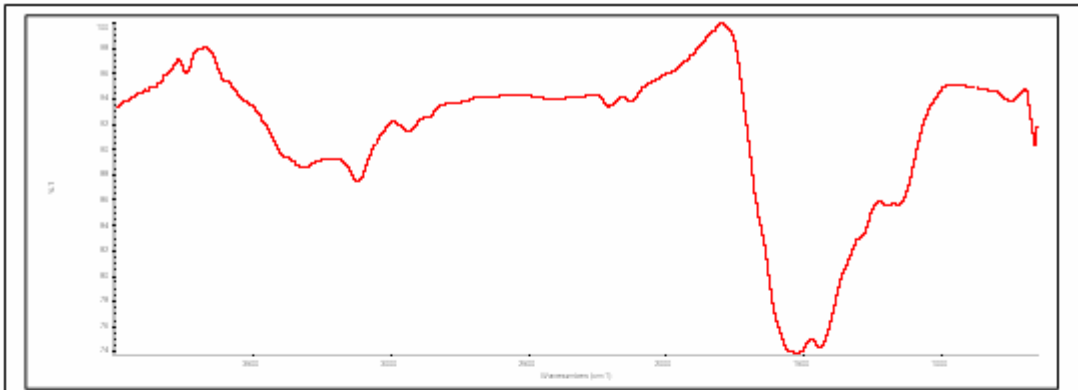
FIGURE 1: Typical MicroCell Film From New Transformer High Power Factor Oil

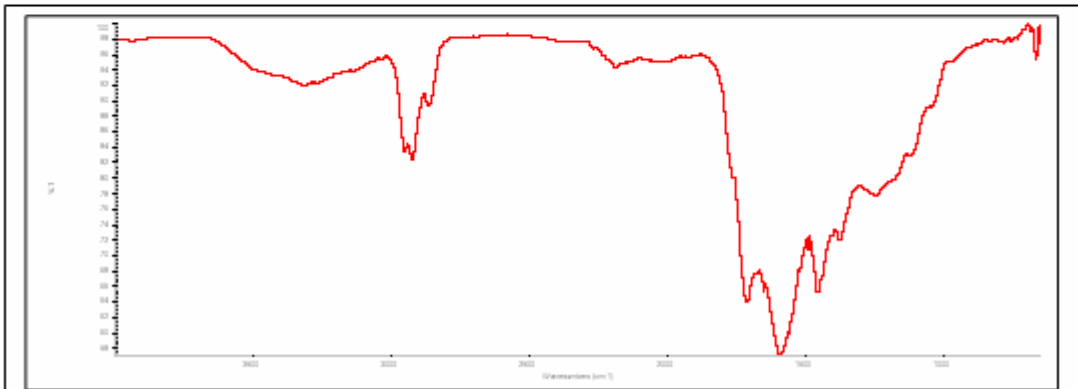
FIGURE 2: Typical MicroCell Film From Old Transformer

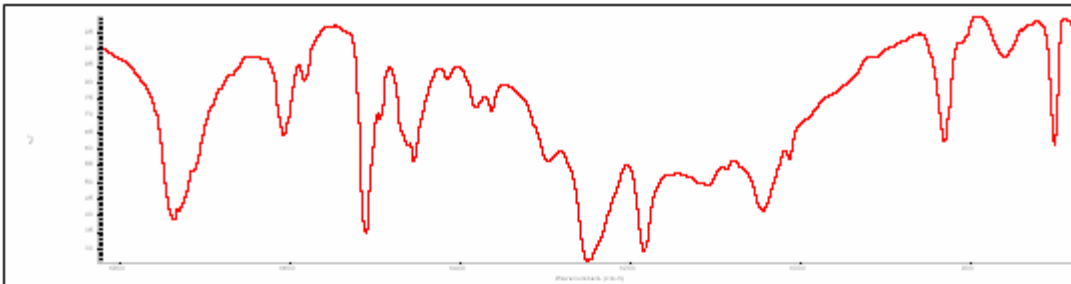
FIGURE 5: The Infrared Spectrum "Fingerprint" Region of a Film-Forming Compound from a Laboratory Test Exposing a Commonly Use Paint to Oil from a Three Year Old Transformer

The oil from the transformer had a power factor of less than 1 at 100 Celsius before the exposure. After five days exposure to cured paint at 80 Celsius the oil had a power factor of 3 when measured at 100 Celsius. The film formed by this oil under the same conditions as the LTC oil above showed this spectrum.

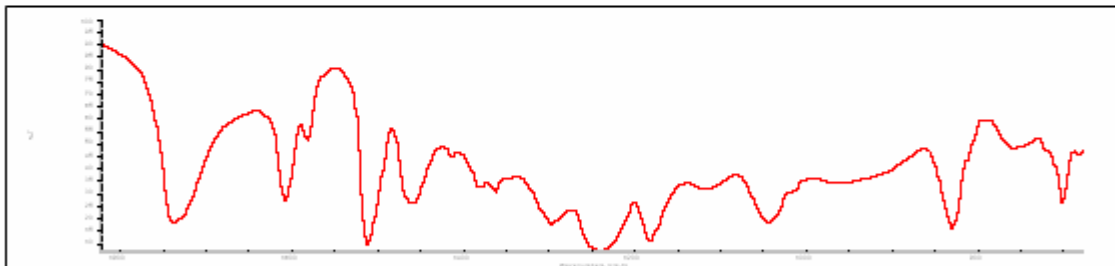
FIGURE 6: The Infrared Spectrum "Fingerprint" Region of a Methylene Chloride Extract from the Surface of the Same Cured Paint Prior to Exposure to Transformer Oil

The paint used in the experiment documented in Figure #2 was extracted by placing a drop of methylene chloride solvent on the fully cured paint that had not been placed in used transformer oil. The drop was lifted and then the methylene chloride was allowed to evaporate. The residue remaining was then analyzed resulting in the above spectrum.

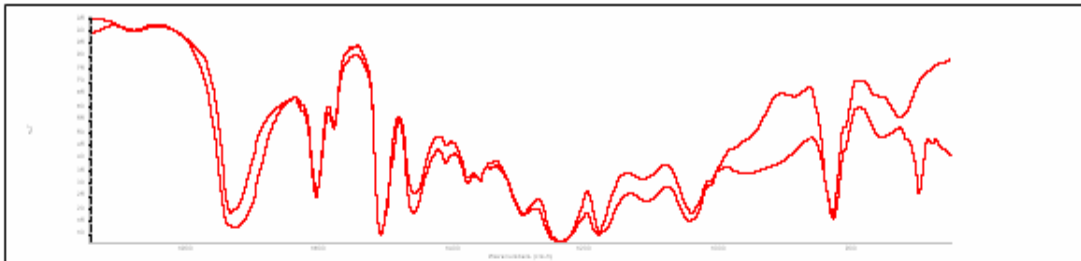
FIGURE 7: Overlay of the “Fingerprint” Region of the IR Spectra from Extracts from Two Paints of the Same General Type from Two Different Paint Companies

These spectra are methylene chloride extracts of two fully cured one-part epoxy paints. The paints are of the same general type though they are produced by different companies and have slightly different compositions. The spectra are nearly identical down to 1000 wavenumbers, where they begin to show differences.

spectrum of the methylene chloride extract from these cured paints looks very similar (see Figure 7). In oils exposed to the cured paints these compounds can be extracted and the FTIR spectrum of these extracts is identifiable as being from the paint. Real world samples of high power factor oil also exhibit this same paint signature (see Figure 8). We have identified an infrared signature for one-part epoxies.

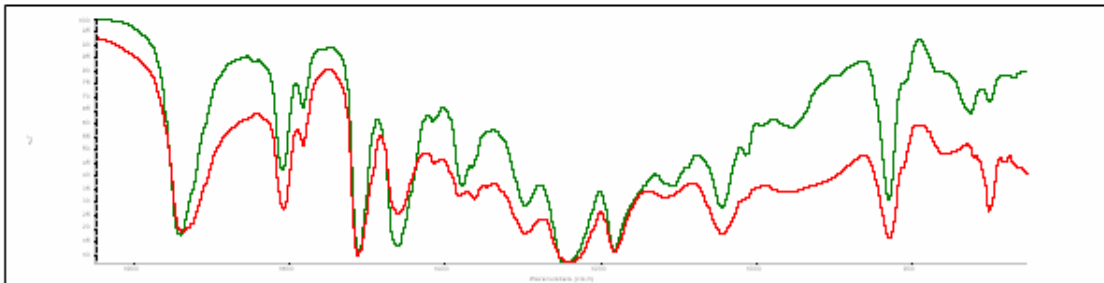
FIGURE 8: Overlay of the IR Spectra from the Paint (lower trace) and the Suspect LTC (upper Trace)

The remarkable similarity of these spectra would seem to implicate extractables from the paint as the dominant film forming components seen in the LTC. There is some difference below 800 wavenumbers. This may indicate a different paint of basically the same formulation.

We know from tests one and two above that when aged oil is exposed to at least some one-part epoxies the power factor increases and this chemical signature is present. We know that some samples from the field that show this anomalous increase in power factor show this chemical signature (see Figure 8). If we removed the methylene chloride extractables from the paint and added that to low power factor oil would the power factor go up? The answer is yes. We exposed twenty square inches of one of the paints to 30 milliliters of high purity methylene chloride for three minutes. The methylene chloride was evaporated down to twelve milliliters and centrifuged to remove any particles and then it was reduced to a volume of one half milliliter. When this extract was added to four hundred milliliters of aged oil with a power factor of just over 1 the power factor went up to 4. The ratio of exposed paint surface to volume of oil was the same in this test as had been the earlier tests where the paint itself was exposed directly to the oil, one square inch of paint to twenty milliliters of oil (1/20). Could the small amount of methylene chloride, less than half a milliliter, cause the change in power factor? Adding five milliliters of clean methylene chloride to five hundred milliliters of oil had no significant effect on the power factor. This test confirms that the compounds that increase the power factor of the oil are in the extract from the paint.

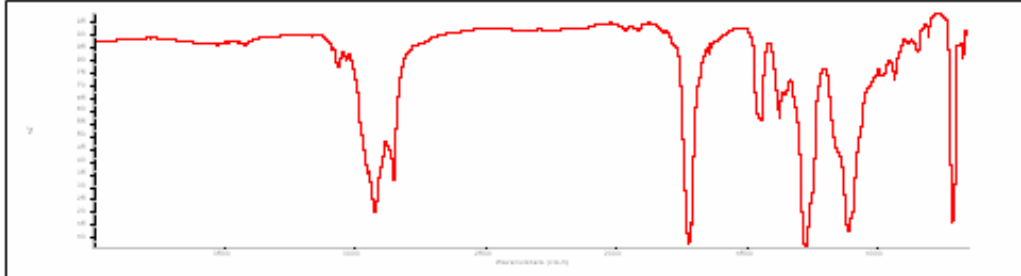
FIGURE 9: The Infrared Spectrum "Fingerprint" Region of a Methylene Chloride Extract from Colored Crepe Paper Used in a Transformer

This is include as an example of extractables from paper, resins, pressboards, plywood, plastics, and other non-metals used in electrical equipment.

problems. In an early phase of the research project all of these materials were tested for extractables using hexane as a substitute for oil and found to have none. When it was discovered that over time insulating oil is better modeled by methylene chloride a new series of tests were conducted. Significant amounts of chemicals were found in most of the materials that were soluble in methylene chloride (see Figure 9). Some of these compounds do contain some interesting carbonyl functionalities.
